Structural Audit-A Case Study of Residential Building Along Western Suburbs

CASE STUDY

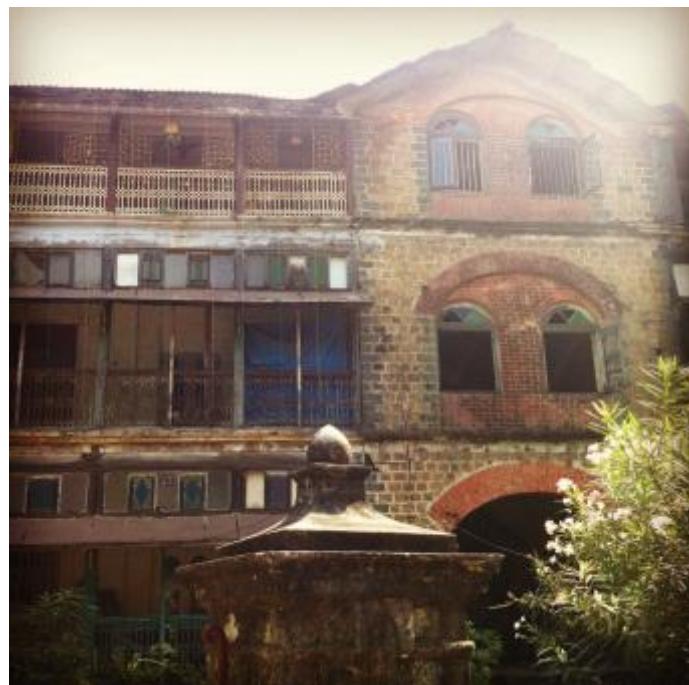
It was designated as Bldg. No. 1 for study purpose. It is Fern Mansion opposite St Andrew Church hill road ,Bandra west. Grade of concrete used was M25. It is G+1 storeyed building. The Owners have observed corrosion related cracks on slab bottom; beams and columns hence they wanted to know the strength & quality of the concrete. Hence they appointed M/s. SIMCON CONSULTANTS PVT.LTD. For assessing the strength & integrity of concrete elements of this building by carrying out non-destructive testing

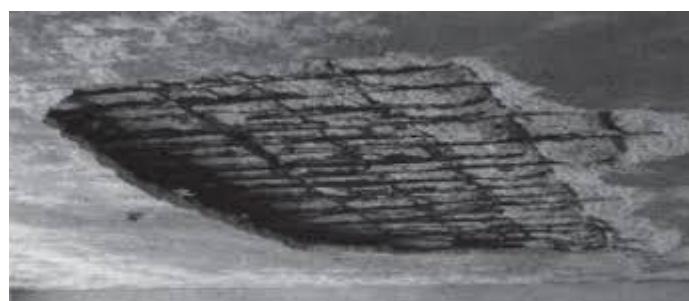
1. VISUAL INSPECTION

- to recognize the types of structural defects
- to identify any signs of material deterioration
- to identify any signs of structural distress and deformation
- to identify any alteration and addition in the structure, misuse which may result in overloading

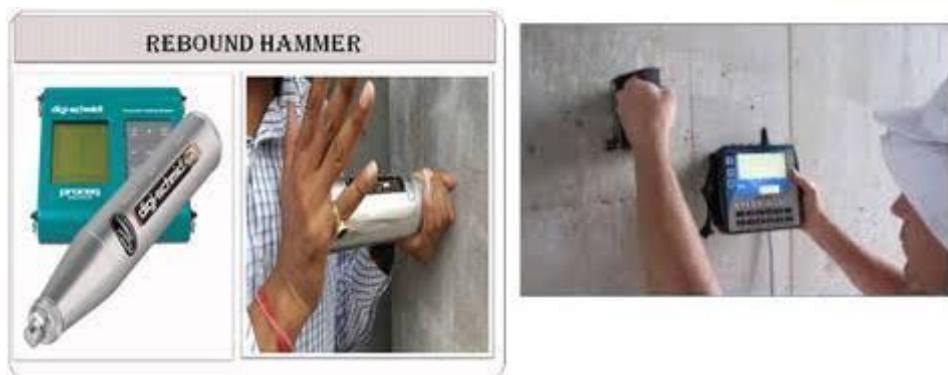
- Rebound hammer test
- Carbonation test
- Halfcell potentiometer
- Ultrasonic pulse velocity test
- Core sampling test

- According to the Visual inspection and NDT tests it is concluded that repairs are required to the buildings
- During performing NDT testings it is observed that various columns and beams whose quality and strength is doubtful for such beams and columns it is concluded that Jacketing should be done
- . According to core test, subject concrete should be classified as of M-25 grade for first level slab & of M-30 grade for first second level slab as per acceptance criteria for concrete
- According to results of carbonation test the line with the inferior quality of concrete, indicates high probability of corrosion in near future as the entire cover concrete is expected to be affected by carbonation
- As per specifications proper repairs and retrofitting should be done, to maintain building in good condition.
